## Post-weld heat treatment of GTAW-repaired aluminium 6061-T6 calliper brackets: Effects on surface integrity and micro vickers hardness

Dipo Ariyo Nugroho\*, Zainal Abadi, Rifelino, Andril Arafat

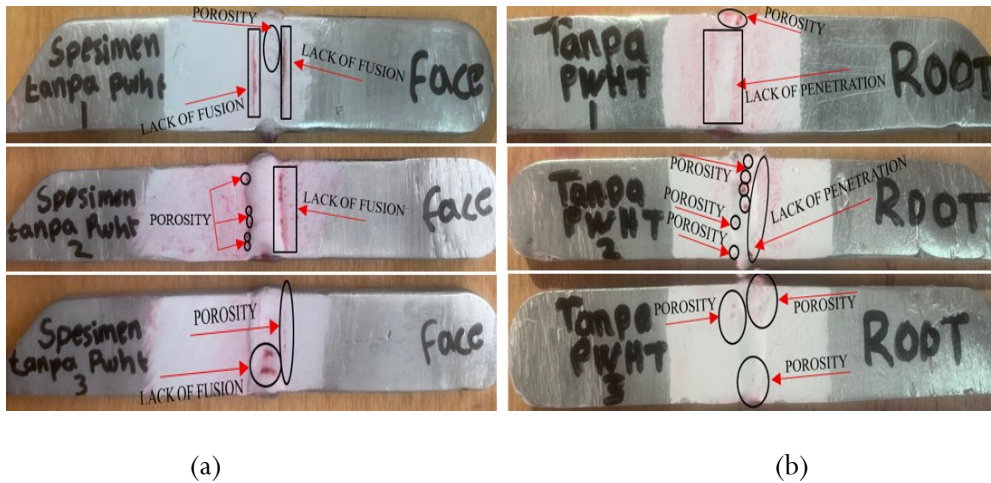
**Figure 12.** liquid penetrant test results for the specimens before PWHT: (a) Face surface and (b) Root

The specimens in the non-PWHT group exhibited various types of surface discontinuities across all three tested specimens. As shown in Figure 12 and Table 3, Specimen 1 exhibited the most severe defects, characterized by two macroscopic linear lack-of-fusion indications extending parallel to the fusion line on the face surface, accompanied by three microscopic porosity indications. On the root surface of the same specimen, two lack-of-penetration indications were observed as irregular and discontinuous red linear indications, together with three linearly aligned porosity indications. Specimen 2 exhibited the highest number of porosity indications, with eight circular indications distributed across the weld surface, whereas Specimen 3 showed a moderate defect distribution consisting of nine indications of porosity and lack of fusion.

The presence of lack-of-fusion indications suggests that the heat input applied during the welding process was insufficient to achieve complete metallurgical bonding between the ER4043 filler metal and the Aluminium 6061-T6 base metal at the fusion boundary. This condition resulted in planar discontinuities that may act as stress concentration sites when the welded joint is subjected to tensile or cyclic loading. Meanwhile, the lack-of-penetration indications observed on the root surface indicate that the molten metal failed to penetrate completely to the root of the V-groove, leaving unbonded regions that may serve as potential crack initiation sites. Porosity in aluminium welds is primarily caused by the evolution of dissolved hydrogen during solidification. In the molten state, aluminium has a significantly higher hydrogen solubility than in the solid state. As the weld metal solidifies rapidly, the dissolved hydrogen has insufficient time to escape from the weld pool and becomes trapped within the solidifying weld metal, forming numerous small voids that appear as porosity.

According to the AWS D1.2 Structural Welding Code—Aluminium, linear indications such as lack of fusion and lack of penetration are classified as critical discontinuities. Therefore, Specimen 1 and Specimen 2 in the non-PWHT group were considered unacceptable based on the AWS D1.2 visual acceptance criteria, as the size and characteristics of the observed linear indications exceeded the maximum allowable limit of 3 mm. In contrast, Specimen 3 in the non-PWHT group and all specimens in the PWHT group were considered acceptable because the remaining defect indications were within the acceptance limits specified by AWS D1.2.

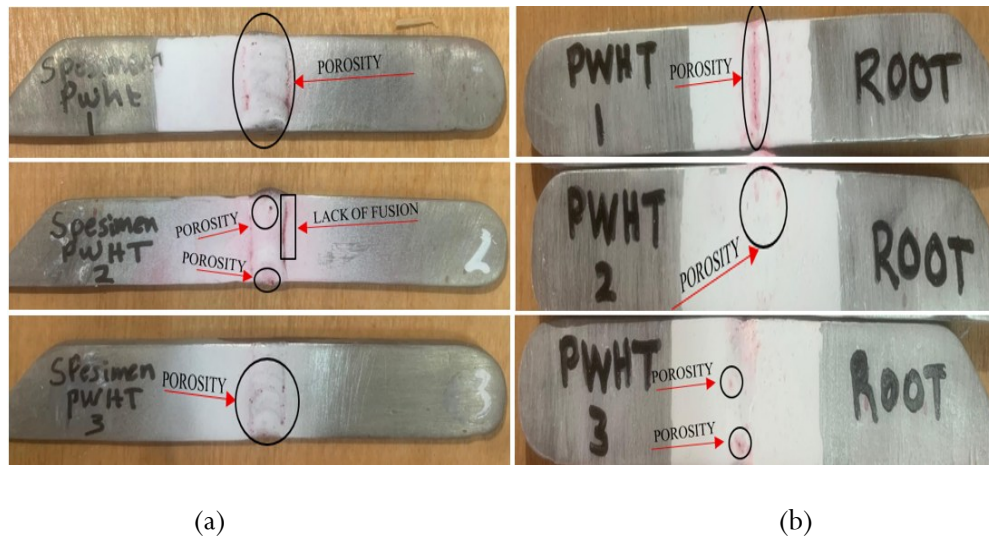
**Figure 13.** Liquid penetrant test results for the specimens after PWHT: (a) Face surface and (b) Root

Following PWHT, the liquid penetrant test results demonstrated a significant improvement in the surface integrity of the welded joints, as shown in Figure 13 and summarized in Table 4. Critical linear discontinuities, such as lack-of-fusion and lack-of-penetration indications, were no longer observed in any of the specimens, except for a single microscopic lack-of-fusion indication on the face surface of PWHT Specimen 2. This indication appeared as a thin, faint, and discontinuous red line, in contrast to the dense and continuous indications observed before PWHT. The remaining discontinuities after PWHT consisted only of scattered microscopic porosity indications, ranging from 2 to 5 indications on each specimen surface. This number was substantially lower than that observed before PWHT, indicating that the post-weld heat treatment contributed to improving the quality and homogeneity of the welded joints.

The improvement observed in the liquid penetrant test results after PWHT should be interpreted from a metallurgical perspective. PWHT does not physically fill or eliminate pre-existing welding defects, such as porosity or lack-of-fusion regions. The voids and imperfections formed during weld metal solidification remain structurally present after the heat treatment process. The reduction in the number and intensity of the penetrant indications is primarily attributed to two mechanisms. First, during the solution heat treatment stage, the aluminium alloy undergoes significant thermal expansion, which can partially reduce the opening of narrow planar discontinuities. As a result, the ability of these discontinuities to retain and accumulate the penetrant is diminished. Second, the relaxation of welding-induced residual stresses during PWHT reduces the driving force responsible for keeping microcrack tips open. Consequently, the penetrant trapped within the discontinuities is less likely to bleed back to the surface, resulting in weaker and less distinct indications. The combined effect of these mechanisms explains why the PWHT-treated specimens consistently exhibited fewer defect indications and no longer showed macroscopic linear indications, even though the geometric discontinuities formed during welding may still remain beneath the surface.

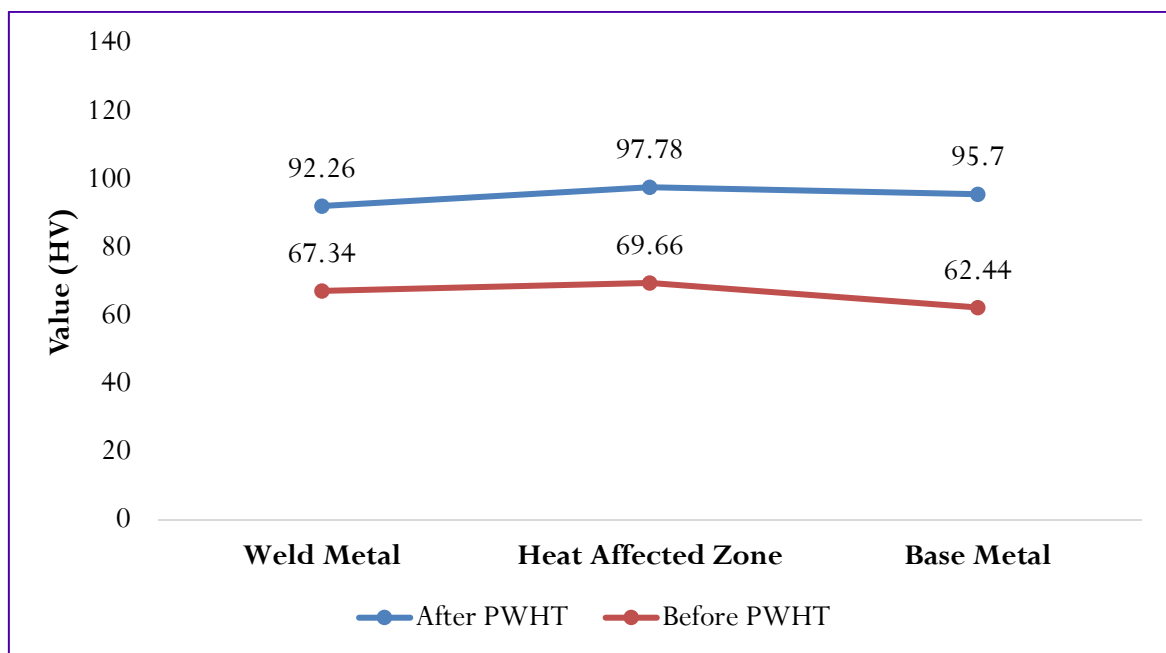
**Figure 14.** Average Micro Vickers Hardness Values (HV) of the Specimens Before and After PWHT

The hardness data presented in Table 5 and Figure 14 demonstrate a consistent and significant reduction in micro-Vickers hardness across all three weld regions after repair by the GTAW process compared with the raw material. Before PWHT, the average hardness in the Fusion Zone (FZ) was 67.34 HV, representing a 35.2% decrease from the average hardness of the raw material (103.96 HV). In the Heat-Affected Zone (HAZ), the average hardness decreased by 32.9% to 69.66 HV, whereas the greatest reduction was observed in the Base Metal (BM), where the average hardness decreased by

The observed reduction in hardness is consistent with the dissolution and coarsening of  $Mg_2Si$  precipitates caused by the high temperatures generated during the GTAW thermal cycle. In the Fusion Zone (FZ), the material underwent complete melting followed by resolidification without controlled cooling, resulting in a relatively coarse dendritic microstructure with limited precipitation strengthening. Consequently, the material exhibited a reduced resistance to plastic deformation, leading to lower hardness values. In the Heat-Affected Zone (HAZ), the temperature was sufficiently high to dissolve the previously formed fine precipitates and promote grain-boundary liquation without causing complete melting. As a result, a softened region with a reduced population of strengthening precipitates was formed, leading to a decrease in hardness. Meanwhile, although the Base Metal (BM) was located farthest from the heat source, it was still exposed to sufficient thermal energy to induce partial over-aging and the coarsening of  $Mg_2Si$  precipitates. This explains why a substantial reduction in hardness was also observed in the BM, despite the absence of melting and the less severe thermal exposure compared with the FZ and HAZ.

Following PWHT, all three weld regions exhibited a significant increase in hardness. The average hardness in the Fusion Zone (FZ) increased from 67.34 HV to 92.26 HV, corresponding to an increase of 36.99% and recovering to 88.75% of the raw material hardness. In the Heat-Affected Zone (HAZ), the average hardness increased to 97.78 HV, representing a 40.37% improvement over the pre-PWHT condition and reaching 94.06% of the raw material hardness. Meanwhile, the Base Metal (BM) exhibited the greatest relative improvement, with the average hardness increasing from 62.44 HV to 95.70 HV, corresponding to an increase of 53.27%. This value is equivalent to 92.06% of the raw material hardness. Overall, the average hardness recovery across the three weld regions reached 91.62% of the raw material hardness after PWHT.

The improvement in hardness is attributed to the re-precipitation of fine  $Mg_2Si$  precipitates during the artificial aging stage of the PWHT process. These newly formed precipitates act as effective barriers to dislocation motion, thereby increasing the material's resistance to plastic deformation. This mechanism, known as precipitation strengthening, is the primary strengthening mechanism responsible for the improvement in mechanical properties and the recovery of hardness in Aluminium 6061-T6 following post-weld heat treatment. The percentage increase in hardness from the pre-PWHT to the post-PWHT condition for each weld region is summarized in Table 6.
