## Post-weld heat treatment of GTAW-repaired aluminium 6061-T6 calliper brackets: Effects on surface integrity and micro vickers hardness

**Abstract:** The caliper bracket is a critical component of a motorcycle braking system that maintains the alignment between the brake caliper and the rotor. Repair of damaged caliper brackets is commonly carried out using the Gas Tungsten Arc Welding (GTAW) process. However, the thermal cycle during welding may alter the microstructure and degrade the mechanical properties of Aluminum 6061-T6. To overcome this limitation, post-weld heat treatment (PWHT), in accordance with ASTM B918, can be applied to restore the material properties and enhance the quality of the welded joint. This study investigates the effect of PWHT on the surface quality and microhardness of Aluminum 6061-T6 caliper brackets repaired using the GTAW process. An experimental approach was employed in which all specimens were welded using identical welding parameters and subsequently subjected to PWHT consisting of solution heat treatment, quenching, and artificial aging. Surface quality was evaluated through liquid penetrant testing in accordance with ASTM E165, while microha

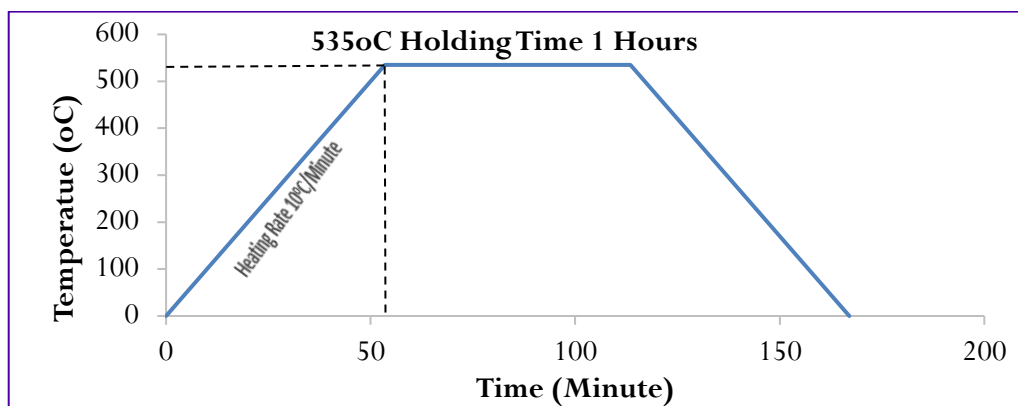
The PWHT process was carried out using a Nabertherm muffle furnace and consisted of three sequential stages. The first stage was solution heat treatment performed at 535 °C with a heating rate of 10 °C/min from room temperature, followed by a holding time of 1 h at the target temperature, as shown in Figure 3.

**Figure 3.** Temperature profile of the solution heat treatment process

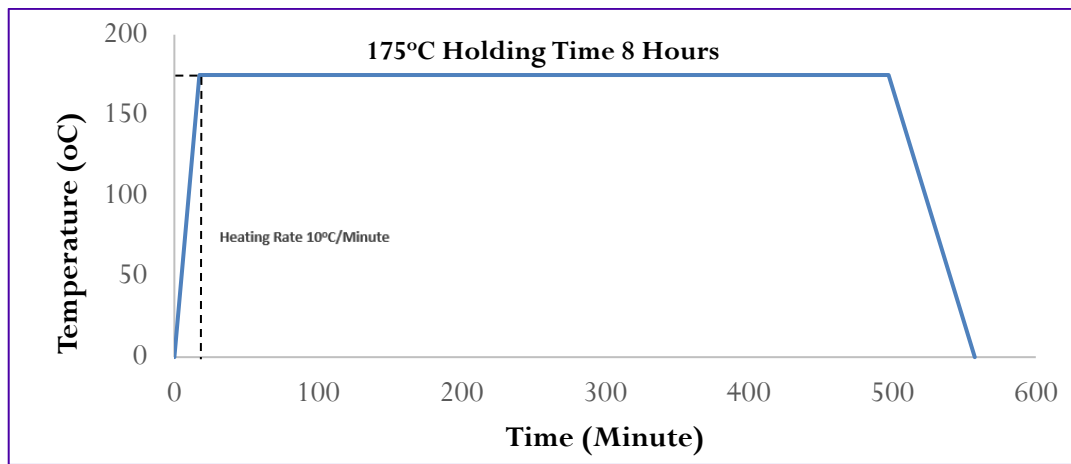
°C/min, followed by air cooling for 10 h until the specimens reached room temperature. Meanwhile, the specimens in the non-PWHT group were maintained at room temperature throughout the treatment period. The temperature profile of the artificial aging process is shown in Figure 4.

**Figure 4.** Temperature profile of the artificial aging process

After the solution heat treatment, the specimens were immediately removed from the furnace and subjected to water quenching using water maintained at a maximum temperature of 43 °C. The transfer time from the furnace to the quenching medium was kept below 10 s to ensure effective cooling. The final stage was artificial aging performed at 175 °C for 8 h with a heating rate of 10

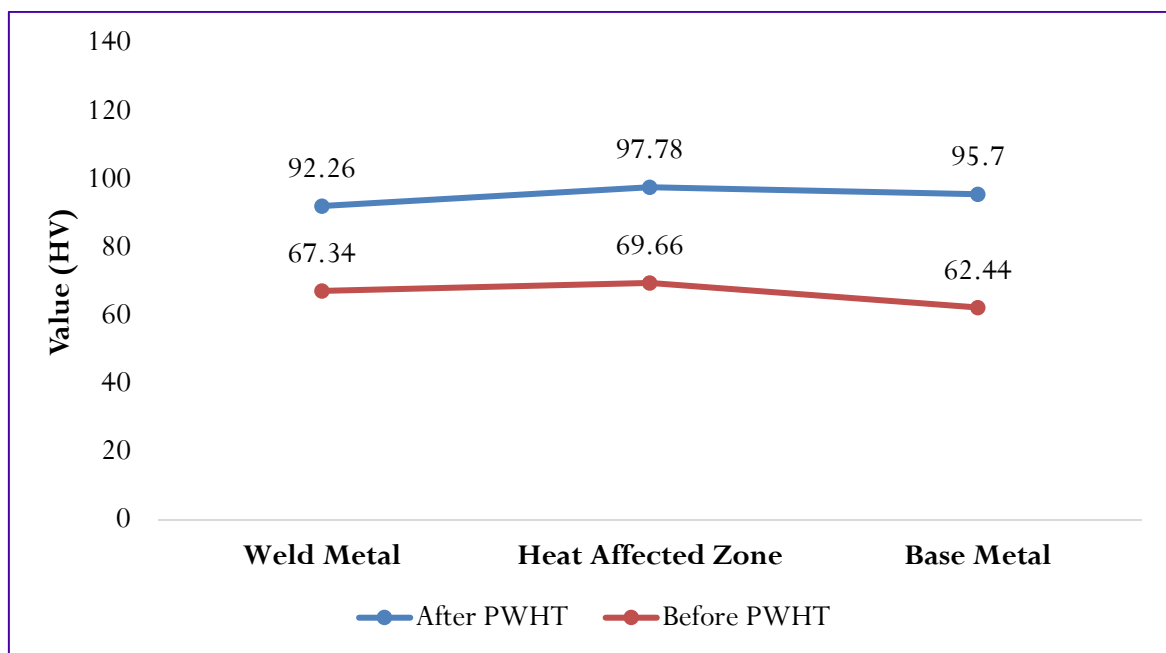
**Figure 14.** Average Micro Vickers Hardness Values (HV) of the Specimens Before and After PWHT

The hardness data presented in Table 5 and Figure 14 demonstrate a consistent and significant reduction in micro-Vickers hardness across all three weld regions after repair by the GTAW process compared with the raw material. Before PWHT, the average hardness in the Fusion Zone (FZ) was 67.34 HV, representing a 35.2% decrease from the average hardness of the raw material (103.96 HV). In the Heat-Affected Zone (HAZ), the average hardness decreased by 32.9% to 69.66 HV, whereas the greatest reduction was observed in the Base Metal (BM), where the average hardness decreased by

39.9% to 62.44 HV. Overall, the average hardness across all weld regions decreased by approximately 36% relative to the initial material condition.

The observed reduction in hardness is consistent with the dissolution and coarsening of  $Mg_2Si$  precipitates caused by the high temperatures generated during the GTAW thermal cycle. In the Fusion Zone (FZ), the material underwent complete melting followed by resolidification without controlled cooling, resulting in a relatively coarse dendritic microstructure with limited precipitation strengthening. Consequently, the material exhibited a reduced resistance to plastic deformation, leading to lower hardness values. In the Heat-Affected Zone (HAZ), the temperature was sufficiently high to dissolve the previously formed fine precipitates and promote grain-boundary liquation without causing complete melting. As a result, a softened region with a reduced population of strengthening precipitates was formed, leading to a decrease in hardness. Meanwhile, although the Base Metal (BM) was located farthest from the heat source, it was still exposed to sufficient thermal energy to induce partial over-aging and the coarsening of  $Mg_2Si$  precipitates. This explains why a substantial reduction in hardness was also observed in the BM, despite the absence of melting and the less severe thermal exposure compared with the FZ and HAZ.

Following PWHT, all three weld regions exhibited a significant increase in hardness. The average hardness in the Fusion Zone (FZ) increased from 67.34 HV to 92.26 HV, corresponding to an increase of 36.99% and recovering to 88.75% of the raw material hardness. In the Heat-Affected Zone (HAZ), the average hardness increased to 97.78 HV, representing a 40.37% improvement over the pre-PWHT condition and reaching 94.06% of the raw material hardness. Meanwhile, the Base Metal (BM) exhibited the greatest relative improvement, with the average hardness increasing from 62.44 HV to 95.70 HV, corresponding to an increase of 53.27%. This value is equivalent to 92.06% of the raw material hardness. Overall, the average hardness recovery across the three weld regions reached 91.62% of the raw material hardness after PWHT.

The hardness distribution pattern observed in this study, in which the Heat-Affected Zone (HAZ) exhibited the highest absolute hardness after PWHT compared with the Fusion Zone (FZ) and the Base Metal (BM), is likely associated with differences in the concentration of dissolved alloying elements and the precipitate distribution in each region following the re-aging process. This finding is consistent with the microstructural observations reported in previous studies. In Aluminium 6061 welded by the fiber laser welding process, post-heat-treatment microstructural variations have been shown to produce different levels of hardness recovery across the various weld regions ([He et al., 2025](#)).

Another noteworthy finding is that the Base Metal (BM), although located farthest from the weld pool, exhibited the lowest hardness before PWHT while also showing the greatest relative increase in hardness after PWHT. This behaviour can be attributed to the occurrence of partial over-aging in the BM during the welding process, where exposure to moderate thermal cycles caused the pre-existing fine precipitates to coarsen and lose their coherency with the aluminium matrix. During the solution heat treatment stage of PWHT, these coarsened precipitates were effectively re-dissolved into the matrix. Subsequently, the artificial aging stage promoted the re-precipitation of a finer and more uniformly distributed population of strengthening precipitates, which acted as effective barriers to dislocation motion. Consequently, hardness recovery in the BM was more efficient than in the other weld regions relative to its over-aged condition prior to PWHT, resulting in the highest percentage increase in hardness following post-weld heat treatment.
